National Highway
Traffic Safety
Administration

Case Vehicle (A): 1998 Chevrolet
 Type: Venture LS, 4 x 2, 4-door APV
 Driver: 64-year-old female
 CDC: 12-LYAS-2, 12-FCEN-3

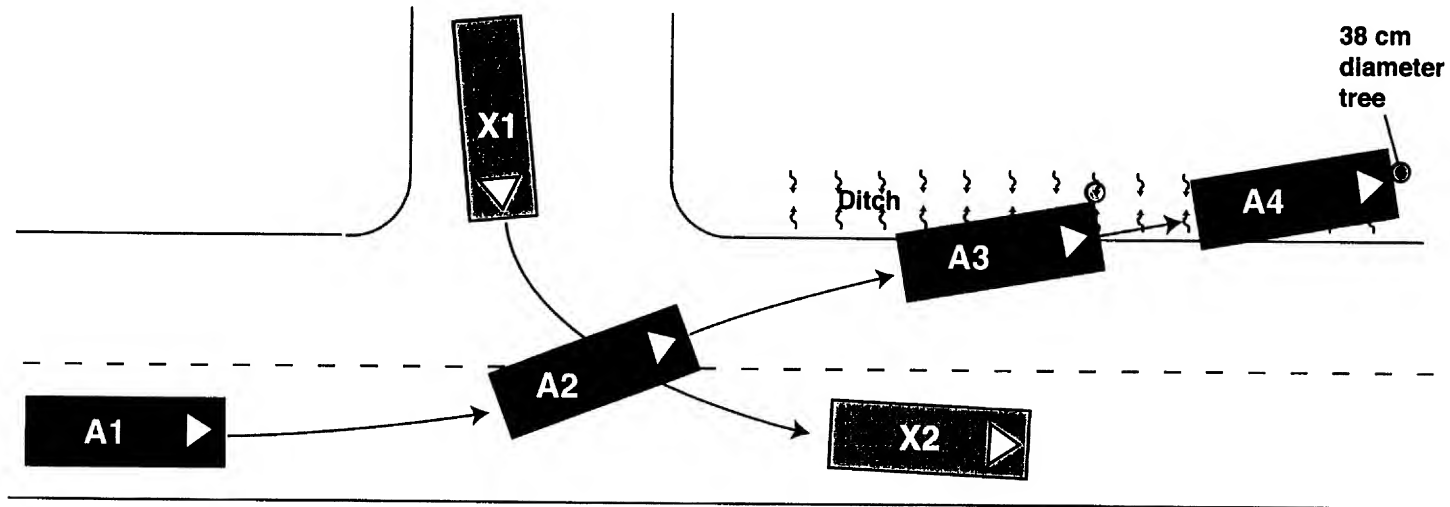
ACCIDENT SCHEMATIC

ACCIDENT DESCRIPTION: Case vehicle (A) was traveling north
when vehicle (X) pulled out of a side road in
front of it. Case vehicle (A) veered to the left
exited the road surface and sideswiped a tree with its left side. Case
vehicle (A) continued on and struck a second tree with its front
center.

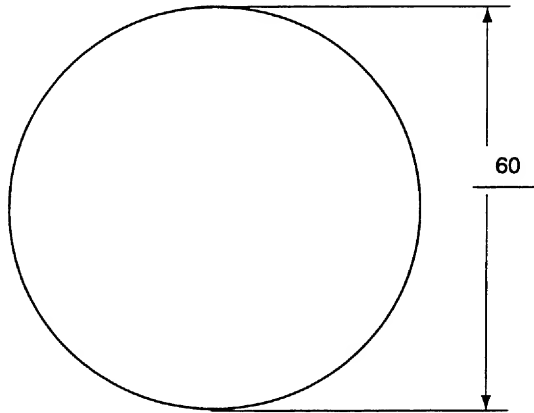
Driver Airbag

This vehicle was equipped with steering-wheel and passenger frontal-impact airbags, and (slides 26, 27 and 28) both deployed during the frontal impact. (Slides 29 and 30) There was no damage to the steering-wheel module flaps/covers. (Slide 31) The passenger airbag module cover was deformed (slide 32) when it contacted and cracked the windshield. (Slides 33 and 34) There was no damage to the steering-wheel rim or (slide 35) spokes. There was no apparent displacement of the steering column. (Slides 36, 37, 38, 39, 40, 41 and 42) There was no other interior damage and no intrusions were noted.

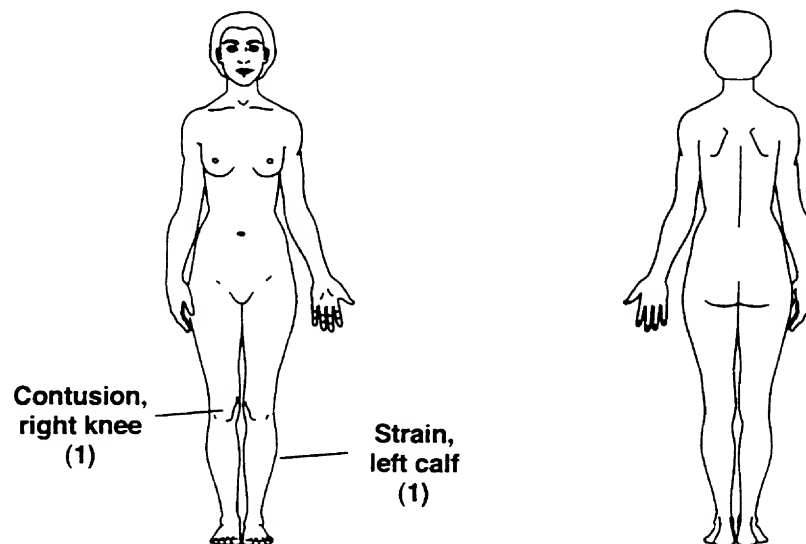
INDICATE LOCATION OF INJURIES.

Injury Description	A.I.S.	Injury Source		
		Definite	Probable	Possible
Contusion, right knee	1	Knee bolster		
Strain, left calf muscle	1			Unknown
<u>Maximum A.I.S. Level</u>	<u>1</u>			
<u>Injury Severity Score</u>	<u>2</u>
